Seismic performance of RC buildings during the $M_w 7.8$ Muisne (Ecuador) earthquake on April 2016: field observations and case study

Abstract The $M_w = 7.8$ Muisne event of April 16, 2016 occurred on Saturday at 18:58:37 local time off-shore of the west coast of northern Ecuador. Several cities in the province of Manabí were directly affected and a state of emergency was declared in six provinces encompassing a total area of 70,000 km². The building stock was severely damaged. 80% of the buildings were destroyed in the city of Pedernales, while several multi-storey reinforced concrete structures totally collapsed in the cities of Manta and Portoviejo. Field observations on the seismic performance of reinforced concrete buildings inspected by the authors are presented in this paper. Also, numerical results from three-dimensional pushover analysis of a representative case study building are discussed. The effect of corrosion and masonry infills, which played a key role in the observed damage, was directly taken into account in the analytical model.

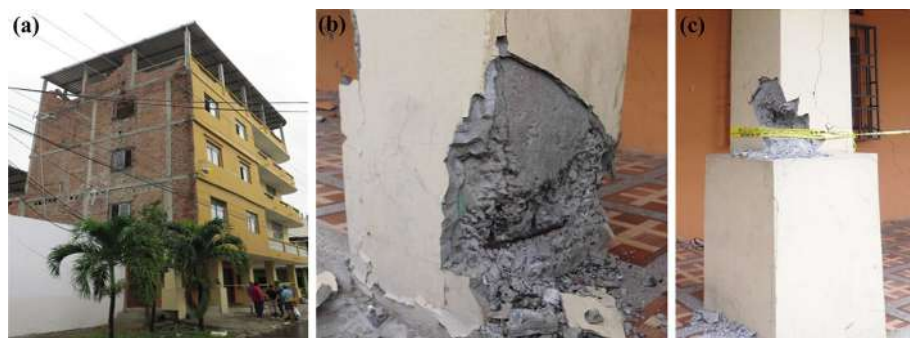
Some typical residential buildings that were found particularly vulnerable to the ground shaking are shown in Fig. 6. The five-storey RC building in Fig. 6a is located in Tarqui, which was the most affected area in Manta declared as ground zero zone. The building presented a soft-storey at the ground level due to removal of masonry infills from the facade plane. Spalling of concrete cover and 20 mm thick plaster was observed at the bottom of the columns, as well as corrosion of longitudinal and transverse reinforcement (Fig. 6b). Some of the ground-floor-columns had been strengthened, hence failure localized immediately after the section reduction in the form of concrete crushing (Fig. 6c). Also note the out-of-plane damage to the infills at the roof level, where the typical layout of the columns was changed during the construction of an additional storey. This type of

Fig. 6 5-Storey RC building with masonry infills located in Tarqui (Manta) (a), and its damage to the ground-floor-columns (b, c)

structural alterations, whereby additional stories are added at different construction periods without reassessment of the structural performance, was commonly observed. This intervention increases the mass and axial load in the existing columns, and introduces stiffness and strength irregularities which can result in undesirable performance.

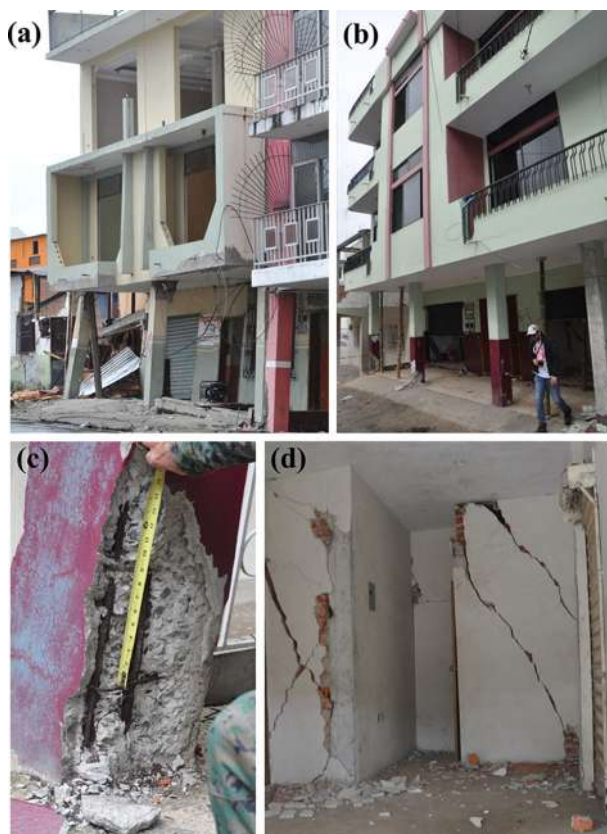
Fig. 7 Soft-storey buildings in Manta (a), damage to the columns (c) and partitions (d)

Further examples of soft-storey frame buildings are shown in Fig. 7a, b. All of these structures were located in Manta, where ground accelerations close to the 475-year design level were recorded. Typical column reinforcement consisted of 14 mm longitudinal bars with 8 mm stirrups spaced at 200–250 mm (250 mm in Fig. 7c), although the current code prescribes a minimum spacing of 100 mm within the plastic hinge region L_o , with $L_o \geq 450$ mm. Figure 7d shows some damage to masonry partitions at the ground level of the building in Fig. 7b, where most of the lateral drift was concentrated.

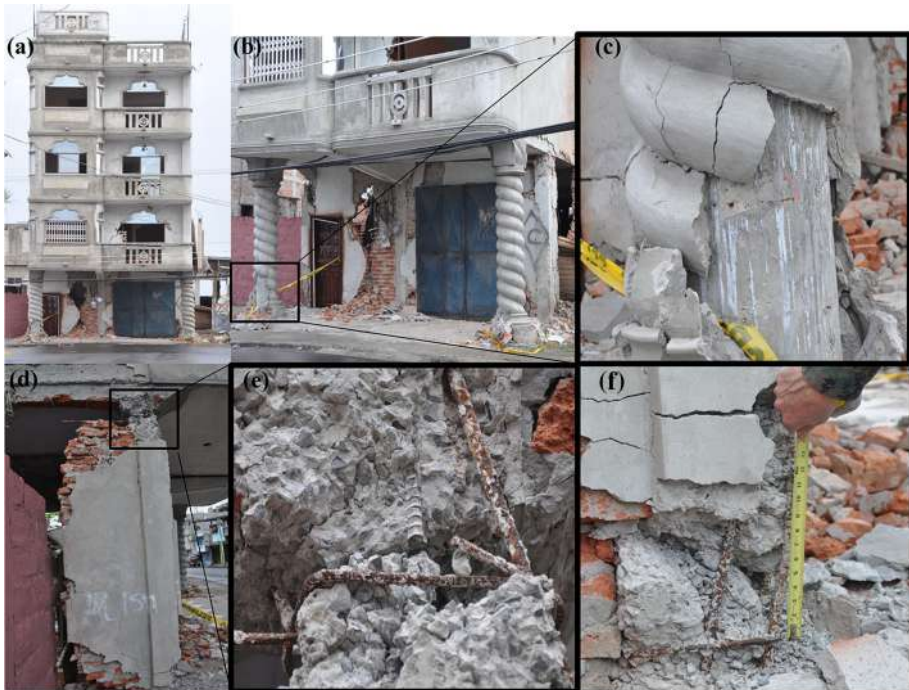
The four-storey building in Fig. 8 was located also in Manta. It is an interesting case of structure that performed relatively well despite presenting several structural and architectural deficiencies, such as removal of an intermediate column at the ground level (Fig. 8b) and the use of heavy column cladding (Fig. 8c). Important detailing deficiencies were found in the column end regions, with stirrups bent at 90° with 300 mm spacing (Fig. 8e, g), and longitudinal bars cut off (Fig. 8e), thus impairing the bending moment capacity in the region of highest moment demand, which ideally should remain elastic according to capacity design principles. According to the current Ecuadorian code, lap splices of column longitudinal bars must occur at column mid-height, outside the plastic hinge regions. Moreover, significant corrosion and loss of bond was observed in Fig. 8e. Despite these deficiencies, the structure did not lose its vertical load carrying capacity, which was partially transferred to the masonry infills.

Fig. 8 4-storey RC building with several deficiencies located in Manta (a), structural irregularities and heavy cladding (b, c), and detailing deficiencies (d, e, f)

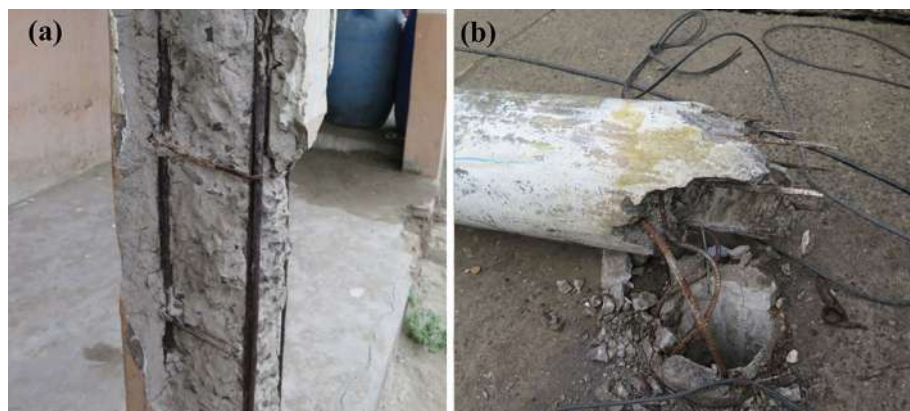
Moreover, insufficient concrete cover, usually <20 mm, accelerated the degradation process. Cover concrete/plaster spalling and fracture of stirrups at the ground-floor-column of an old two-storey building is shown in Fig. 9a. This failure occurred at column mid-height as a result of extensive corrosion and expansion of reinforcement. Also, several columns were found excessively slender (20×20 cm² in Fig. 9a). The current NEC-2014 code specifies minimum column dimensions of 30×30 cm². An electrical RC post with a hollow circular cross-section is shown in Fig. 9b, which failed due to insufficient anchorage length and corrosion of the rebars. Note also that smooth rebars were used in Fig. 9a.

Fig. 9 Damaged column (a) and collapsed electrical post (b)

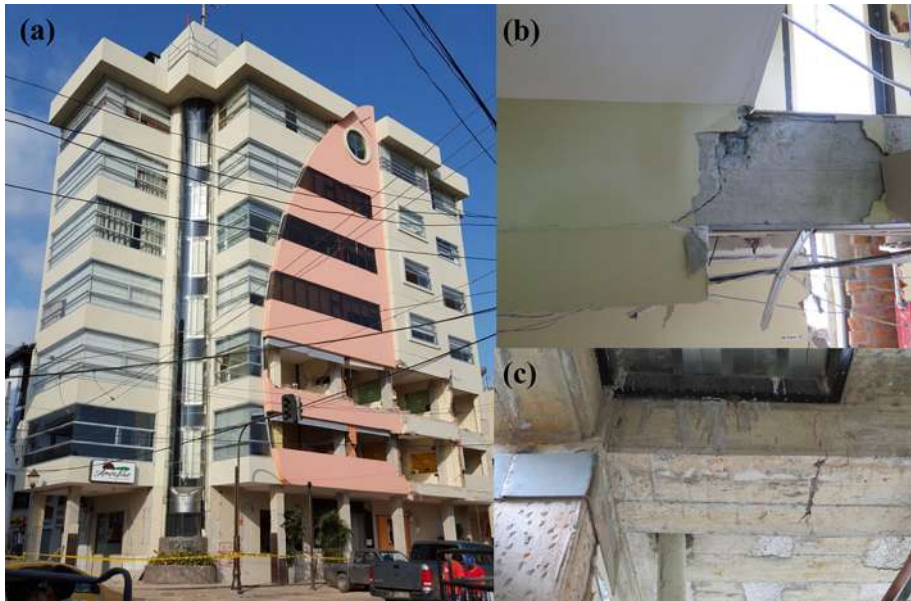
The Ceibo Dorado Hotel, constructed in 2010 and located in the ground zero zone in Portoviejo, is shown in Fig. 10a. It consists of an L-shaped 7-storey RC structure with no seismic joints between adjacent blocks. Damage to interior masonry partitions and exterior infills was observed mostly at lower storeys. Structural irregularities introduced by the interior staircase resulted in concrete crushing and flexure-shear cracking of the landing slab (Fig. 10b). Also, signs of flexural yielding and beam elongation were noticed in some beams framing into perimeter joints (Fig. 10c), likely accentuated by torsional effects. Overall the structure performed relatively well and without any apparent permanent drift, despite being its natural period close the local amplification peak at 0.5 s in Portoviejo.

Fig. 10 7-storey Hotel Ceibo Dorado in Portoviejo overall damage (a), damage to the staircase (b) and perimetral beams (c)

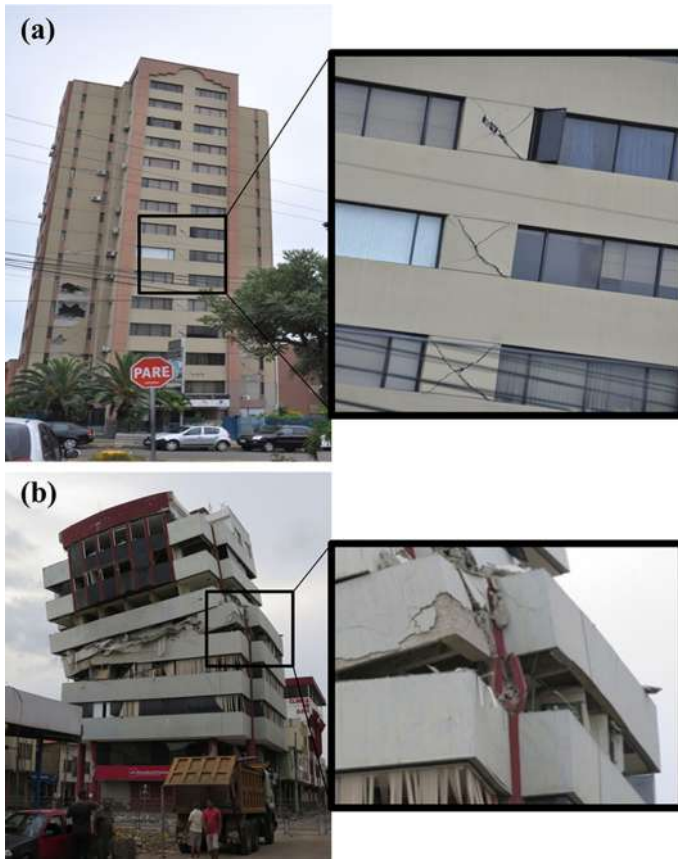
The 15-storey hotel Oro Verde, built in the late 1970s and located at the beach front in Manta, is shown in Fig. 11a. It is a good example of a long period structure with damage at intermediate storeys, presumably due to higher mode effects. The damage consisted of diagonal shear cracks localized in masonry infills (Fig. 11a). Note that the structure is isolated from neighboring buildings, hence no group interaction occurred.

An impressive local collapse was triggered in the Mutualista Pichincha building, a 10-storey RC structure built in the late 1980s and located in downtown Portoviejo (Fig. 11b). The upper three storeys collapsed on top of the lower part of the building across a soft-storey plane, likely influenced by the short-column effect from interaction with external cladding panels (see close-up). Local witnesses reported that the upper part was slowly “creaking” with every aftershock. The building was recently demolished under controlled implosion.

Fig. 11 15-storey RC building in Manta (a) and partial collapse of 9-storey RC building in Portoviejo (b)

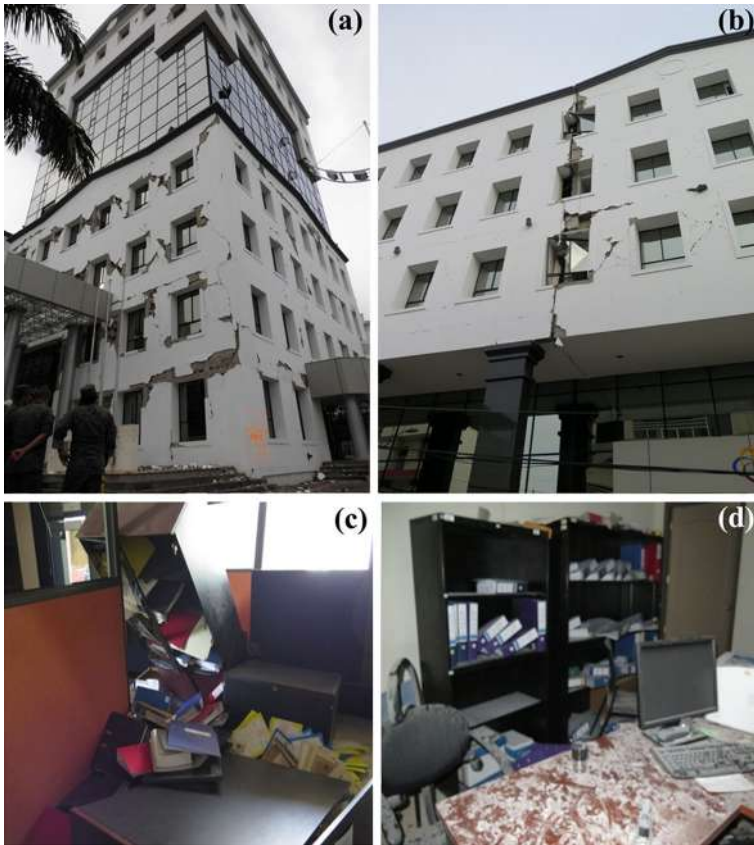
and 4.5 m long shear walls. The structure did not suffer any important damage, with only minor damage at the construction joint due to pounding between slabs (Fig. 12b). However, non-structural damage was important. Diagonal shear cracks were noticed in the facade masonry, consisting of hollow concrete bricks. Damage to the contents, e.g. overturning of bookshelves, was significant in the upper storeys (Fig. 12c) where greater floor accelerations occurred, whereas in the lower storeys drift sensitive components were more affected (Fig. 12d).

Fig. 12 **a** Exterior damage to the Supreme Court building, **b** pounding at the construction joint, **c** non-structural damage at upper stories and **d** at lower stories

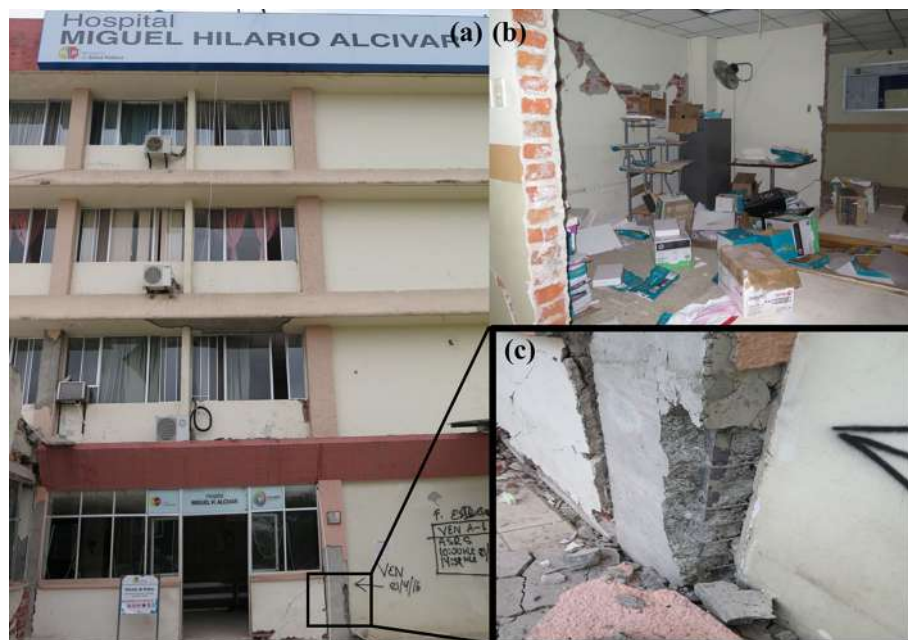
As previously mentioned, many hospital facilities were left inoperative due to extensive non-structural damage, although none of them completely collapsed. The structural system was similar to that of residential buildings, i.e. RC frames with URM infills, but with stiffer and stronger members resulting in higher floor accelerations and wide-spread damage to acceleration sensitive components, such as medical equipment. The Miguel Hilario Alcivar hospital in Bahía de Caráquez (Fig. 13) represents an interesting example of retrofitted structure after the 1998 Bahía de Caráquez earthquake. Retrofitting consisted in the addition of six shear walls and jacketing of some perimeter columns. Minor structural damage occurred during the present earthquake, with some spalling of plaster and concrete cover in the boundary wall elements (Fig. 13c). However, damage to the contents and the psychological impact on people located in the building during the earthquake left it inoperative (Fig. 13b).

Fig. 13 **a** Damage to the retrofitted Miguel Hilario Alcivar hospital in Bahía de Caráquez, **b** interior damage to partitions and content, and **c** structural damage in the wall boundary

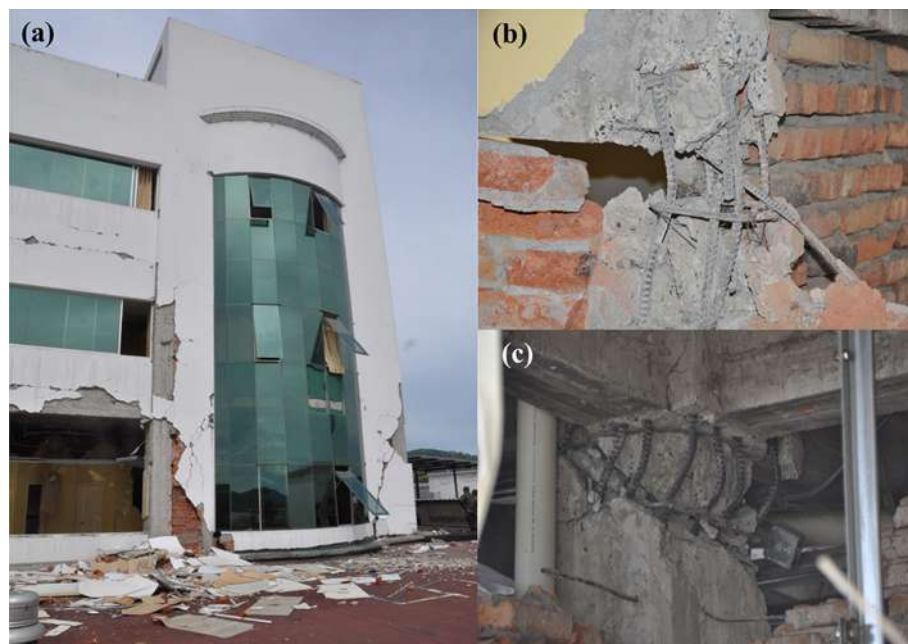
The Solca Hospital in Portoviejo was left only 40% operative after the earthquake. The building was built in early 2000s and it consisted of multiple, up to three-storey units separated by expansion joints. One of the units presented an additional two-storey tower which did suffer extensive damage to the non-structural and structural components (Fig. 14a). In Fig. 14b, damage to a non-structural column of an interior infilled frame is shown. The interior column of the tower (Fig. 14c) presented insufficient number of

stirrups and lack of transverse confinement, resulting in combined axial-shear failure and buckling of longitudinal reinforcement.

Fig. 14 **a** Damage to the building tower of the Solca hospital in Portoviejo, **b** failure of a non-structural column, and **c** shear failure of an interior column
